PROPOSALS FOR CONSOLIDATION AND REPAIR OF TWO GRAIN SILOS

Abstract: *The paper presents the behaviour of some reinforced concrete grain silos, in service for more than 40 years respectively. All of these silos have suffered multiple durability deteriorations for which an in-depth inspection was performed. Studies focused on diagnosis and level of deteriorations, on rehabilitation and strengthening. A decision as to level of intervention took into account the estimated remaining service life of each silo. The paper deals with the practical application of repair and strengthening method.*

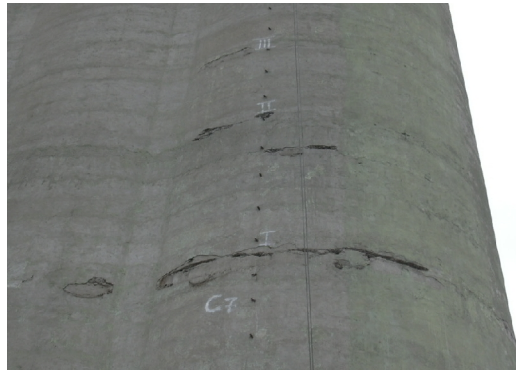
The inspection showed deep deteriorations in concrete, multiple local small deteriorations, such as cavities, holes (some of them pierced), detached bars cover, inconsistent concrete, unfilled holes provided for slip form supporting bars figure 3.

On one of the cells a repair was attempted about 20 cm on the wall height and about 3m long on the cell circumference. The repair was accomplished by filling with concrete

from the inside and sheet metal formwork on the outside. At this intervention it was found that the filling concrete did not adhere to the old concrete, there being a separation plan between them. Also the area is crossed by cracks with 0.7 mm openings, extended beyond the repair.

Fig. 3. *External cell surface before inspection*

So, for filling of all the cavities or holes, the concrete mix of concrete class C20/25 included aggregates of to 3 mm or 7 mm, an acrylic bonding agent to be applied on old concrete surface and a super plasticizer, so as the concrete vibrating became not needful.

Other small deficiencies of the concrete, as well as of the reinforcement concrete cover, were repaired using epoxy bonder or epoxy concrete. The cracks exceeding 0.3 - 0.5 mm were injected using low viscosity epoxy resin like Sure-Inject, Day-Chem Ar Bond or Acrylic latex agent [4-7].

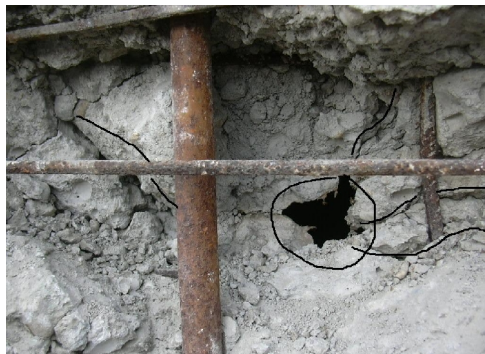
At the bottom of another cell there is a limited but profound deterioration. Here, the brittle concrete has been cleaned due the weather, leaving a horizontal bar a few free vertical bars. These bars show advanced corrosion and loss of adhesion to concrete.

- local cavities or casting interruptions like Figure 4;
- cracks caused by the perforations in the walls practiced for temporary windows and ventilation pipes;
- segregation areas or lack of compactness;
- the emergence of vertical and horizontal reinforcements, with friable concrete, caverns and wall piercing inward, marking an error of concrete sliding, Figure 4.

Fig. 4. *Local cavities and in-deep reinforcement corrosion*

These deficiencies were the main cause of the further deteriorations, such as:

- friable or expelled concrete, concrete settling;

- cracks, deformations;
- reinforcement corrosion (not active).

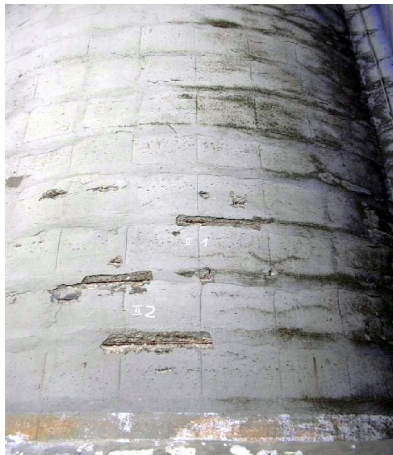
The main deteriorations of this silo were observed to concrete and reinforcement on external cells surface only see Figure 5.

Fig. 5. *Deteriorations on external cell surface*

The main concrete and reinforcement deteriorations were observed only on the outer side of the cylindrical walls, especially at form panel joints and they consisted in:

For the repair of structural concrete we recommended different procedures using special, reliable chemical products which became available in the country at the time, such as epoxy bonder or epoxy concrete and an outside concrete surface protection by impregnating it with chemical products: Multi-Purpose Construction Grout or Rapid Resin Repair [8], [9].

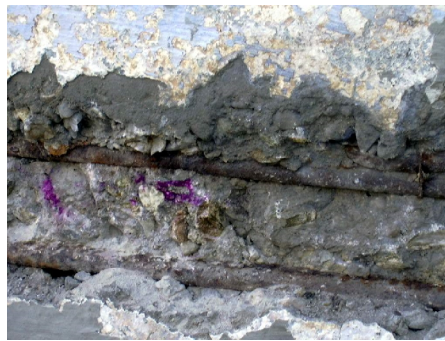
- detachments of the reinforcement concrete cover ,where the thickness measured 5-15 mm;
- segregation areas;
- adherent or in-deep corrosion of the reinforcement in this zone;
- concrete deterioration due to freeze-thaw, see Figure 6.

Fig. 6. *In-deep reinforcement corrosion*

These deteriorations were caused by the external weather action combined with an insufficient concrete cover of outside layer of the reinforcement and of concrete segregation.
