CONSTRUCTION CONDITION ASSESSMENT – WHY AND HOW?

V. LUPASTEANU¹ C. CHINGALATA¹ R. LUPASTEANU¹

Key words: *Construction Condition Assessment, quality, strengthening, maintenance.*

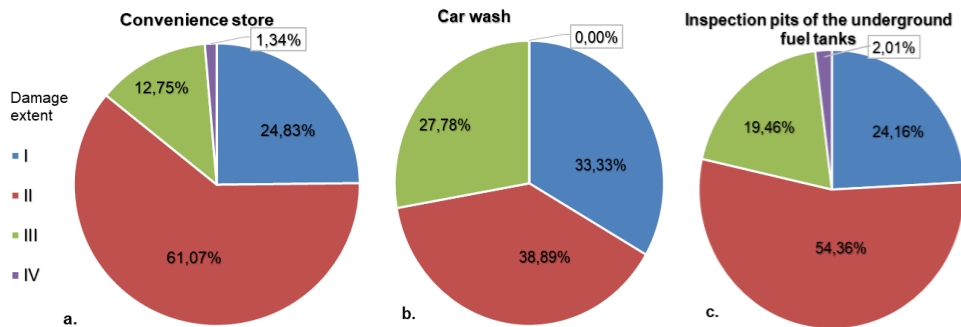
Fig. 3. Results of the condition assessment activity: a) convenience store; b) car wash; c) inspection pits of the underground fuel tanks

149 fuel stations have been investigated in order to elaborate the condition assessment reports. In this respect, investigation tables have been elaborated, for the seven of the most representative components. Most of the fuel stations components have no damaged elements, thus fulfilling the quality requirements. The identified damage extent of the components corresponds mainly to the minor defects category, having a local extension (level II) and do not directly affect the quality requirements, according to their specific purpose. Among the causes underlying the second level damage extent are: natural degradation of materials, exceeding the normal operating time for some of the protection and finishing layers, lack or failure to perform on time maintenance and repair works, the quality of the intervention works and the used materials and, respectively, the lack to apply the repair measures recommended in the condition assessment reports etc.

The high percent of defects corresponding to the IIIrd level was identified at the car wash, mainly due to the applied technical solution: jet wash stand with vertical structural elements and without any closing elements at the roof level. A very low percent of the investigated elements had multiple, generalized defects (IVth level), affecting the quality requirements, and thus, the normal functionality of the fuel station. For the latter situations, intervention measures have been recommended: complex investigation and

safety evaluation, immediate intervention works and replacement of the damaged elements.

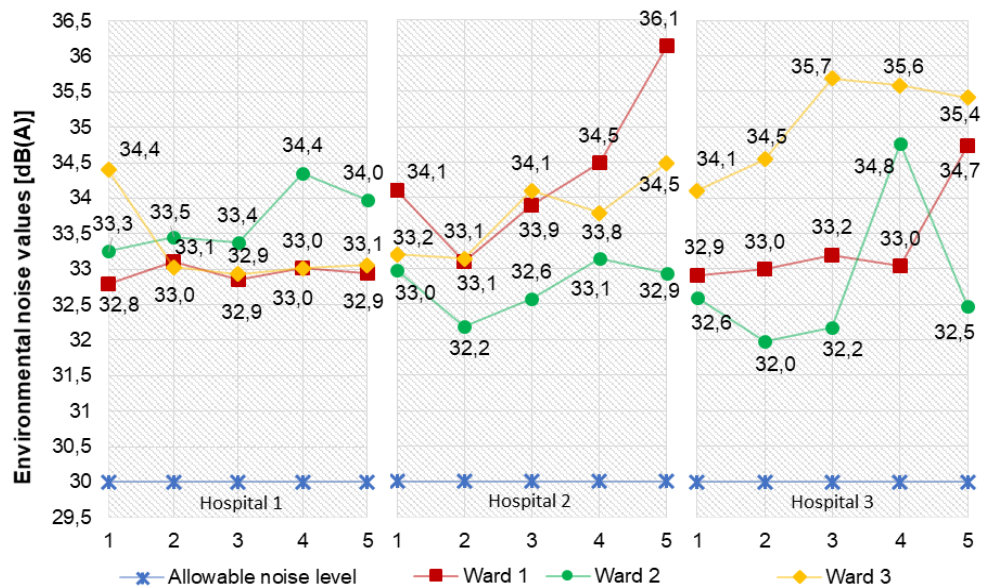
Fig. 6. Recorded environmental noise level values - 2 bed hospital ward [9]

By analysing the noise level values recorded inside the functional units, it can be concluded that the measured values exceed the allowable limits, for almost all the investigated units. The higher differences were recorded in the case of the 2 bed hospital ward because this type of functional unit needs specific acoustic design treatments in order to obtain the 30 dB(A) limit, for the patient rest and recover.

In order to increase the acoustic characteristics of the construction envelope and partitioning elements, some improvements can be recommended, for increasing the absorbed sound energy. These intervention works can be applied both at the interior part of the functional units (sealing gasket replacement, replacing the actual finishing layers with some porous ones, using acoustic absorption boarding, replacing the existing exterior doors and windows with ones having increased acoustical properties) and at the exterior of the building (use of layers with silent road wear – porous asphalt, increasing the distance between the street and the building – in case of new constructions and usage of green barriers in the space between the street and the building).

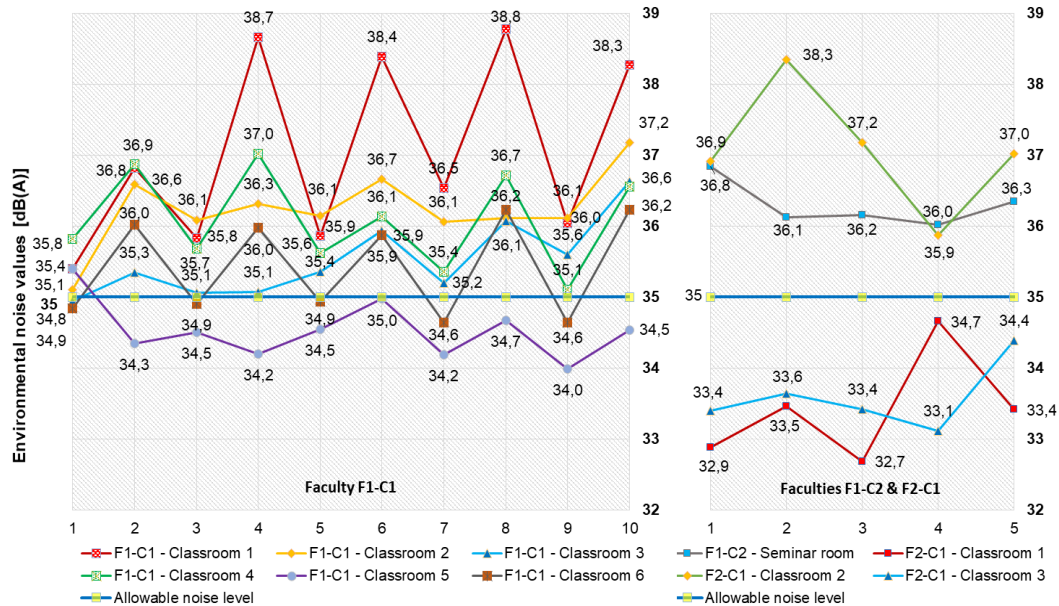
Fig. 7. Recorded environmental noise level values - classrooms inside learning facilities

For the classrooms within learning facilities, inside the functional units positioned near facades adjacent to public street higher environmental noise values were obtained, mainly due to traffic noise. The main noise sources are the traffic noise (vehicle and tram movement, horns, emergency vehicles hooter) and the background noise.

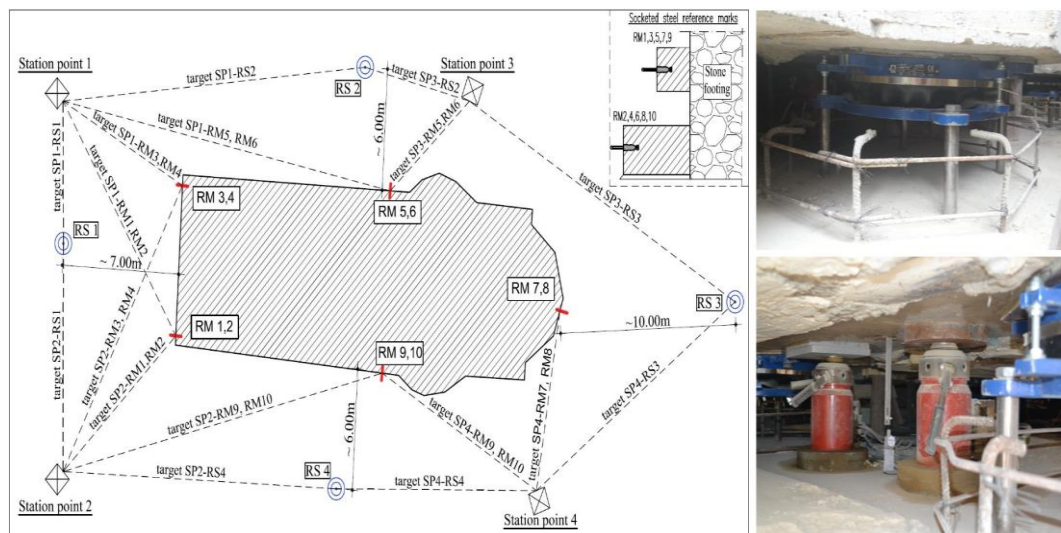
Fig. 8. Displacement and settlement monitoring system; FPS supports and hydraulic jacks

severely damaged during on-service stage and, in order to assess the damage extent, on-site investigations have been made. Important damages were discovered: general longitudinal fractures, consecutive transversal fractures at the porch, nave, narthex, and sanctuary level and the porch walls tended to separate from the narthex. These damages correspond to a typical damage mechanism for the orthodox churches [12].

pressure in the hydraulic jacks was constantly correlated with the displacement values provided by the LVDTs. Previously, after the load has been entirely transferred to the isolators, a final horizontal position check was made, both using the LVDTs and the survey method. The actual recorded values were compared to those considered reference equilibrium values, and the deviations ranged between -0.25 and +0.30 mm.

The damage extent of the structural system of the church enforce the development of a rehabilitation plan and, in the case of the St. Nicolae Aroneanu church, it was established that the traditional strengthening solution could not be applied. Instead, the base isolation solution was a suitable approach, consisting in decoupling the structure of the church from the ground. In order to apply the technical solution, a reinforced concrete structure was erected, consisting of a raft foundation below the existing foundations, a r.c. carrying frame underneath the perimeter footway and a r.c. slab over the carrying frame. The base isolation system is being composed of 48 friction pendulum sliding (FPS) isolators that are installed between the raft foundation and the carrying frame. The technical documentation of the church rehabilitation was designed by conf. dr. eng. Ionel Gosav, member of the Department of Concrete, Building Materials, Technology and Management, from Faculty of Civil Engineering and Building Services of Iași.
