SUSTAINABLE DECONSTRUCTION OF TWO BRIDGES

Abstract: *Deconstruction is an actual concept strongly correlated with sustainability. When existing structures are not more able to fulfill the present needs, deconstruction can give them a second life with regard to the sustainable concept of development. Deconstruction includes renewal, rehabilitation or reconstruction; it is more economically to refurbish, rather than rebuild. The paper presents two typical examples in this direction: The reconstruction of an existing bridge situated in an active agricultural area and the re – use of a former portal crane girder for a pedestrian bridge.*

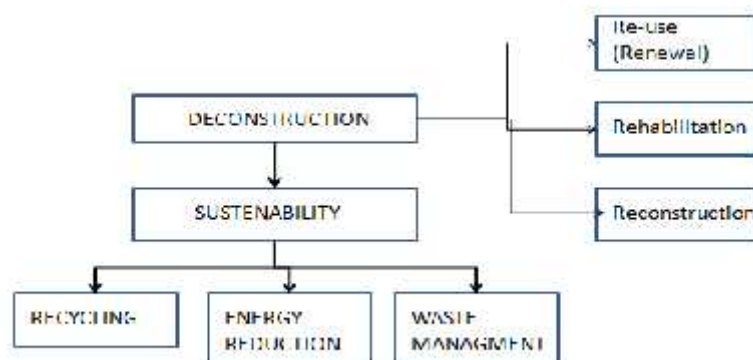
Fig. 1. *The general concept of deconstruction*

reconstruction. These operations must be correlated to environmental sustainability [1]. Deconstruction helps to save the need for new materials and resources (Fig. 1).

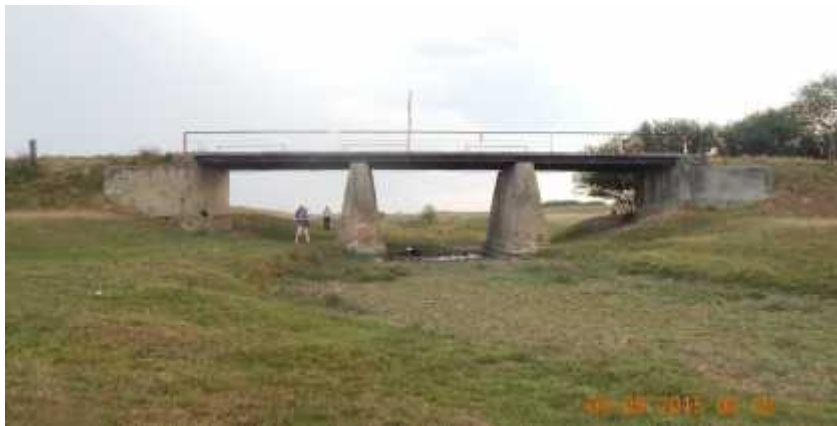
The bridge “Timi ina” situated on a local highway, connecting two localities in the Timis County, is an existing structure with a neglected maintenance in time. In present the technical condition of the bridge is rather bad (Fig. 2).

Fig. 2. *The existing structure*

The bridge has three spans, each of 7.00 m. The structure is composed by simple supported steel profiles (IPN 320 and IPN 400) and a deck of prefabricated concrete slabs without dowels disposed in 1994 (the former solution had wooden sleepers). The structure has no footpath or handrails. In the last years heavy agricultural machines were introduced in the

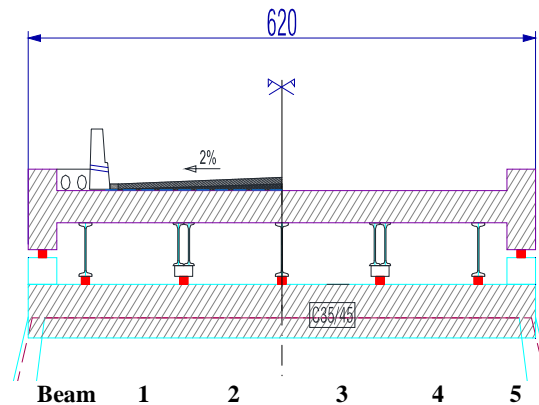
Fig. 5. New bridge - deck

For the superstructure, in principle the existing rolled profiles will be maintained and completed with new ones; the beams will be strengthened by ties; elastomeric bearings and seismic devices will be introduced, wind bracings are disposed. The existing profiles IPN 400 will be reused, after sand blasting and painting (disposed as marginal beams, 1 and 5) and adding new profiles IPN 320 which will be

transformed into 2 IPN - (twin) beams, longitudinally welded, constituting intermediate beams 2 and 4 in marginal and central span and finally the introduction of a new central beams (gr. 3) of IPN 400. All steel beams are reinforced with 2 round steel tie-rods with a diameter $D = 28-35\text{mm}$ of high-quality steel with high tensile strength - $f_{yk} = 600-900\text{ N/mm}^2$ (Fig. 6). The final constructive depth is equal to $h_c = 0.83\text{m}$. Neoprene bearings are disposed on the piers and abutment.

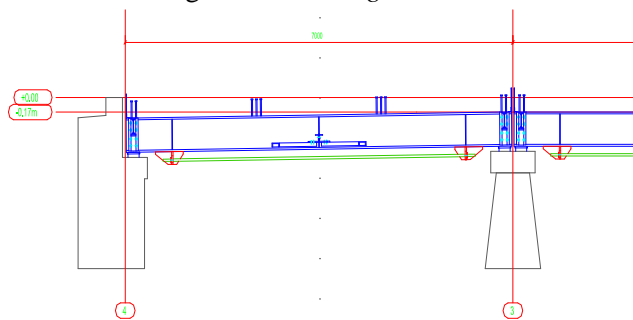
Fig. 6. Strengthening with steel ties

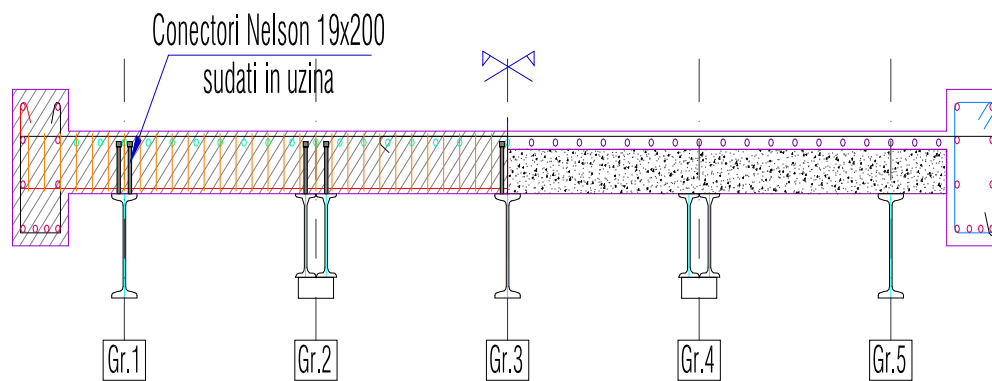
The deck will be realized independent in each span; the existing precast slabs $550 \times 200 \times 17\text{ cm}$, are maintained (after pressure water cleaning) and reinforced by in situ concrete topping; intermediate concrete cross girders are introduced,

which are connected to the steel girders with NELSON $19 \times 200\text{ mm}$ shear connectors, realizing the composite action. The final thickness of the deck is 24 cm (Fig. 7).

Fig. 7. Bridge deck with cross girders

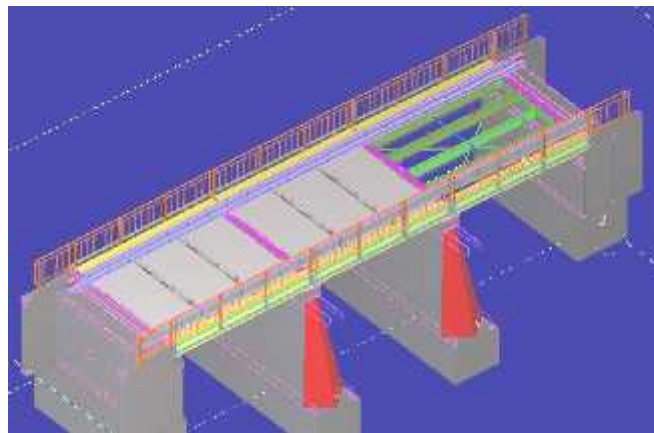
Fig. 8. General view of the renewed structure

The structure is now able to take the present heavy standardized loads (Fig. 8).

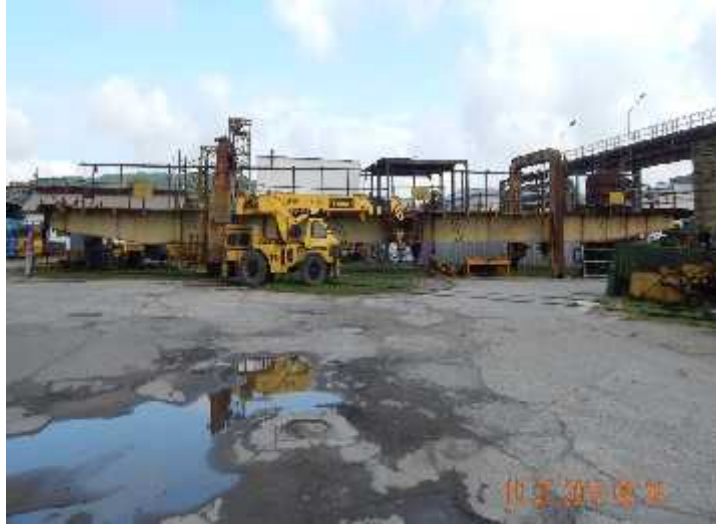
Bistrița (Fig. 9). The characteristics of the crane are: $Q_{max} = 20/5$ Tones and $D=20+2 \times 6$ m. The main girders have a box girder cross section, with $b=650$ mm and $h=1300$ mm in the field, respectively 700 mm on the bearings. The web is 8 mm thick supporting the crane rail. Statically it is a cantilever girder with $L=6.00 + 20.0 + 6.00$ m. Both main girders situated at a distance of $B=4208$ mm, are connected at

Fig. 9. The disaffected crane

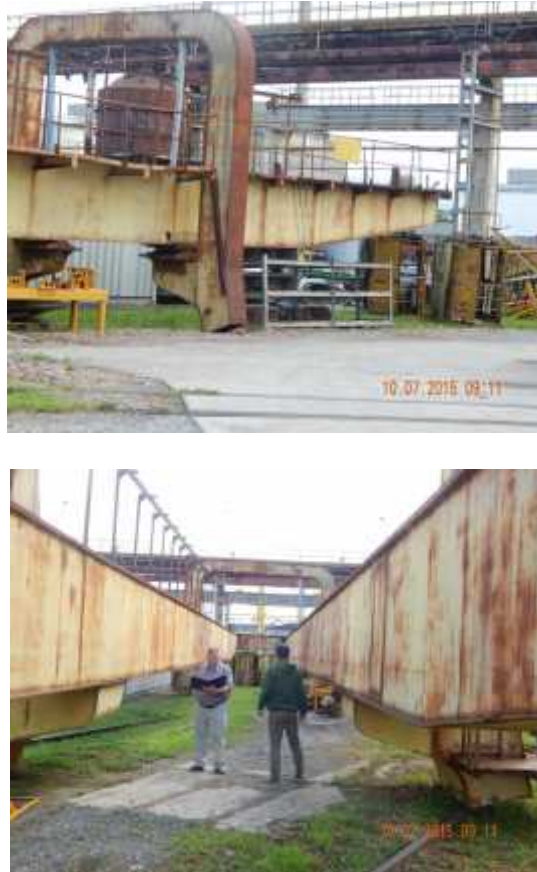
the end with two cross girders. The technical condition of the structure is rather good (Fig. 10); a relative recent general control made by “ISCIR - National Authority for Control and Approval of Boilers Pressure Vessels and Hoisting

Equipment” is positive. Even the thickness of the elements corresponds to the initial values from the project. The welds were verified by the magnetic particle inspection; the result was satisfactory.

Fig. 10. General view of the crane girders

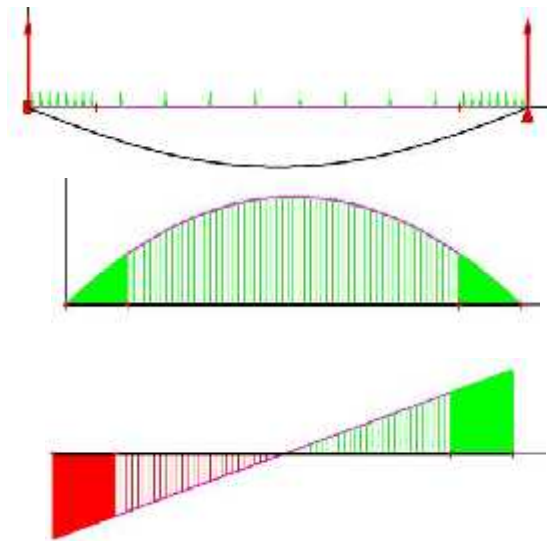
The statically scheme of the structure is a simple supported girder with a span of 37,40 m (Fig.11).

Fig. 11. Statically scheme of the crane girder

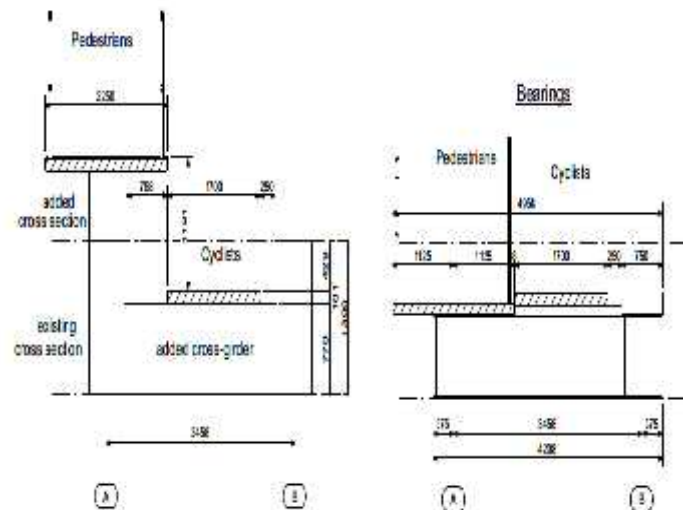
The final proposal is presented in Fig.12. A pleasant architectonic effect is obtained by placing at different levels the pedestrian and the cycling (bike) lane.

Fig. 12. Final proposed solution
