EXPERIMENTAL TESTS ON LIMESTONE FILLERS MORTARS USED AS REPAIR SYSTEM

R. CHENDEŞ¹ S. DAN¹

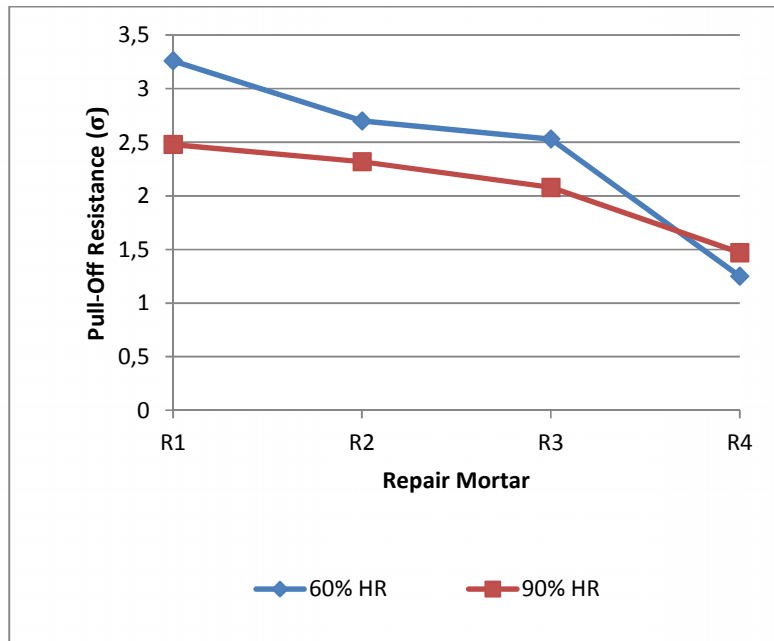
Fig. 1. *Pull-off test interpretation*

The minimum adhesion value, measured by pull-off test, should be greater than 1.5 MPa for structural repairs and 0.5 MPa for non-structural repairs [8]. The results are presented with regard to storage conditions and repair mortar (Table 2 and Figure 1). Results given in Table 2 are the average value obtained on 3 samples.

From Figure 1 we can conclude that the pull-off strength is always bigger for 60% than for 90% RH under 30% substitution of cement by limestone. But even for high substitution values, adhesion remains high. For both RH storage conditions, the bond strength is getting smaller with increasing limestone content.

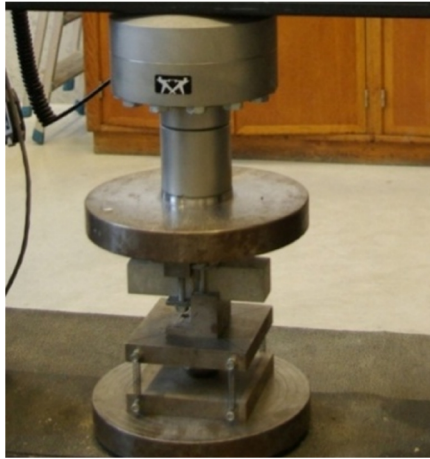
Fig. 2. *Direct shear test*

Results from the initial direct shear test (Figure 2) are inconclusive: air bubbles were observed at the interface in the repair mortar. Adhesion doesn't seem to concern the entire interlayer surface but only the darker zones from the interface (Figure 3). Values of the bond shear strength are between 0.9 and 6.8 MPa. For these reasons, samples of size 60 x 40 x 40 mm were cut from the pull-off slab and the shear tests were performed again. The results of the shear test using the new samples are presented in Table 3.

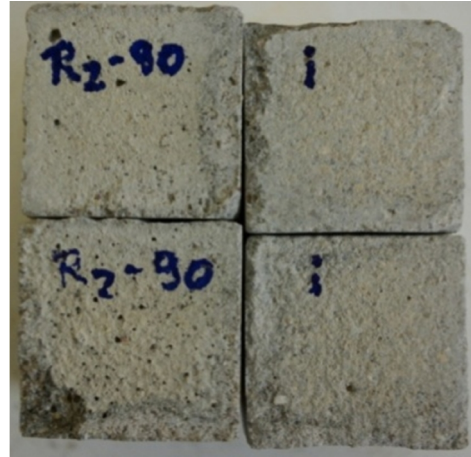
Fig. 3. *Example of interface*

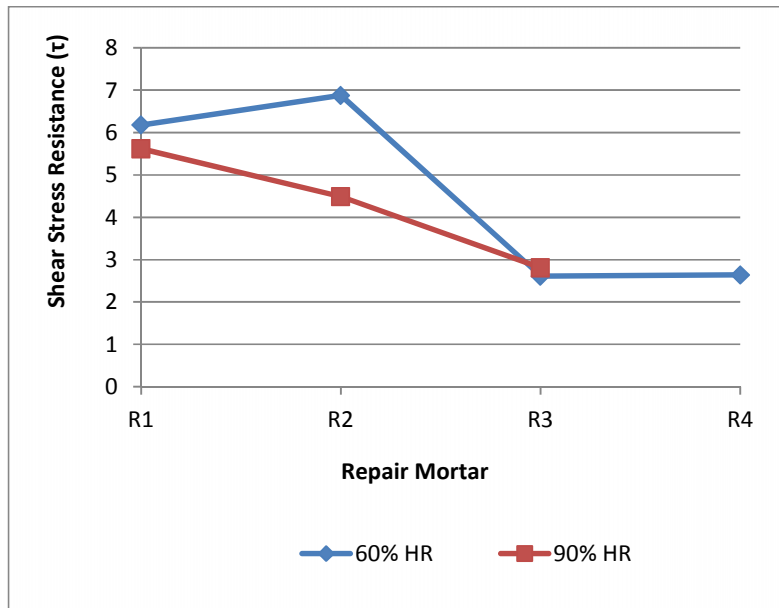
Fig. 4. *Shear test interpretation*

Figure 4 is giving results of shear strength for the two different relative humidity (RH) storage conditions and the different repair mortars.

There is no clear influence of storage conditions on shear strength. It seems, however, that 60% RH is more favorable, at least until 30% limestone substitution rate (R3). Above this value, behaviors seem to be similar.
