PROPOSALS FOR CONSOLIDATION AND REPAIR OF TWO GRAIN SILOS

Abstract: *The paper presents the behaviour of some reinforced concrete grain silos, in service for more than 40 years respectively. All of these silos have suffered multiple durability deteriorations for which an in-depth inspection was performed. Studies focused on diagnosis and level of deteriorations, on rehabilitation and strengthening. A decision as to level of intervention took into account the estimated remaining service life of each silo. The paper deals with the practical application of repair and strengthening method.*

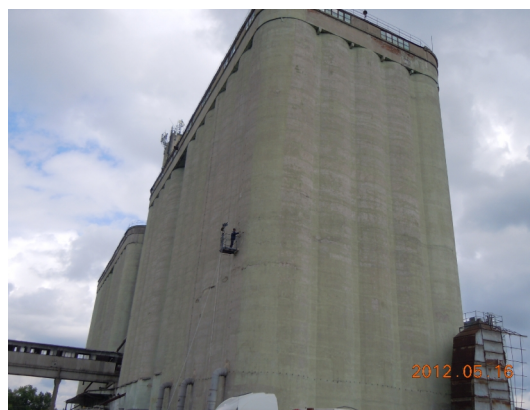
Fig.1. *Calarasi silo*

The first grain silo from Calarasi storage, presented in the Figure 1, base built 45 years before the inspection. It is composed of four batteries with total 42 cylindrical cells, one cell of 7 m in outside diameter and 36 m in high, 36 pockets cells and 20 stellate cells with the wall thickness of 18 cm. The slip form method of construction was used [1].

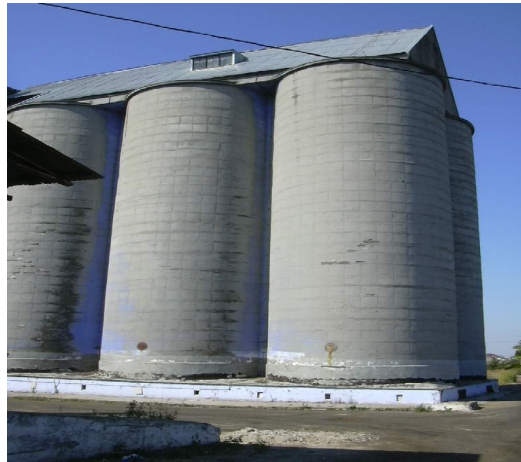
Fig. 2. *Dragos Voda silo*

The second silo from Dragos Voda storage, presented in the Figure 2, base built 40 years before the inspection is composed of one battery with 6 cylindrical cells, one cell having a diameter of 7.30 m and 20 m high, with a wall thickness of 15 cm. Two stellate cells are formed between the cylindrical cell walls.
